Transport
Canada

TP 6980E

Issue 3&4/2004

Canadian Aviation Service Difficulty Reports

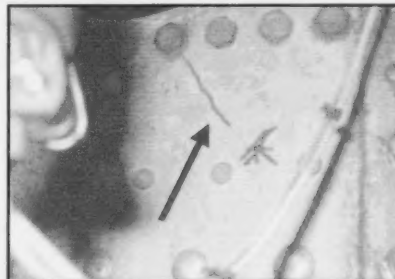
Keel Beam Web Area Cracked

While troubleshooting an APU snag, maintenance personnel discovered a crack in the keel beam web load control valve area, STA 870. The damage is being repaired in accordance with SRM 53-10-9. Crack length approximately 3.5 inches in length.

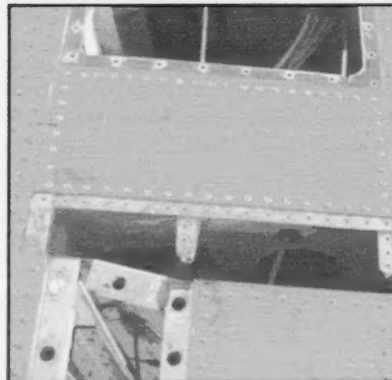
BOMBARDIER CL215 1A10 - Water Bomber
Control Cable Corroded

During a structural repair to the right rear wing-to-fuselage frame angle, a panel at WS 60.80 adjacent to the rear spar, had to be drilled off to facilitate the repair.

Corrosion was discovered on the rudder/aileron interconnect cable, P/N 215-90381-2, which lies directly under this panel. The corrosion was removed and upon a closer inspection, several broken strands were noticed.

The maintenance manual was consulted and it was determined that the cable was damaged beyond limits. The cable was removed and replaced with a serviceable one. It is worth noting that the damage would be impossible to spot had it not been for the removal of the riveted panel. This is an area that is normally inaccessible.

When maintenance is being performed in areas where access could not normally be gained, AME's are reminded to be diligent and check for additional defects.

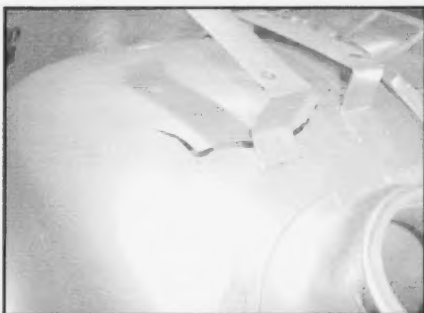
SDR # 20040322006

**BOMBARDIER CL600 1A11**
APU - Plenum Assembly Fractured

When the APU (auxiliary power unit) was started, it would not accelerate past 40%. Investigation found a large split (crack) on the outer casing of the plenum assembly, P/N 3846068-5.

The APU was removed and further investigation revealed a completely detached broken bracket lying in the APU compressor inlet duct. This piece was identified as a broken flange from the inside of the inlet duct. Further inspection of the compressor rotor showed significant damage from contact with the aforementioned broken bracket. The elbow tube assembly that is attached to the inlet plenum, P/N 3846007-1, was also found to be loose and worn from vibration.

When this APU was installed, it was reported to have a high pitch whine but the cause was never determined. However, the operation was normal until it would not accelerate on start-up. A possible cause of the "whine" was from an out-of-balance condition.

Continued operation of the subject APU resulted in APU fatigue-related failures of the compressor inlet bracket, which then contacted the compressor rotor, creating a massive "out-of-balance" condition and eventual failure of the APU plenum assembly and other parts.

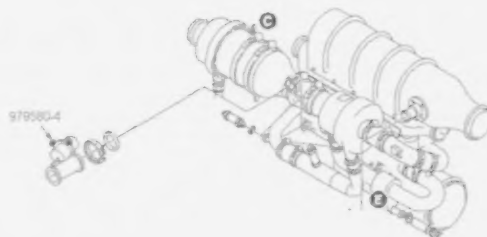
After engine start, crew was unable to obtain cold air-conditioned air out of the left air-conditioning pack. Engines were shut down and maintenance was notified of the snag. Maintenance discovered that the low-limit valve butterfly, P/N 979580-4, was no longer attached to its shaft.

The butterfly was located in the duct just below the air-cooling turbine. The air-cooling turbine was also replaced as a precaution due to suspected FOD damage.

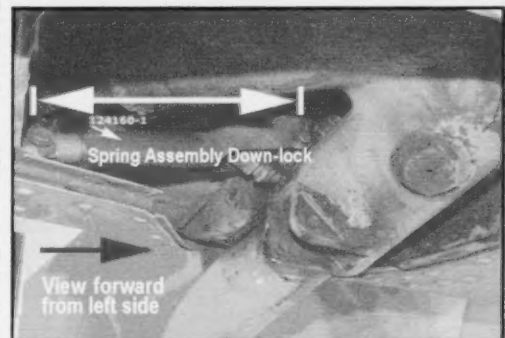
SDR # 20040423003

The main landing gear down-lock spring assembly sliding action was restricted by accumulation of dirt and debris. The down-lock, P/N 124160-1, was unable to fully engage, resulting in an "unsafe" gear indication. Inspection revealed wet lubrication attracted debris and dirt in the spring assembly concentric sleeve and spring.

Section 2 of the Cessna inspection manual is vague regarding lubrication type and applicability, and states in part - "...and any other friction point obviously requiring lubrication".

The submitter recommends that dry lubrication be used in this area and increased awareness of individual inspection programs for aircraft operating in "off-airport" locations, such as gravel and dusty strips.

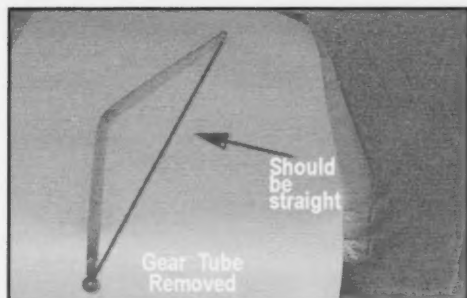
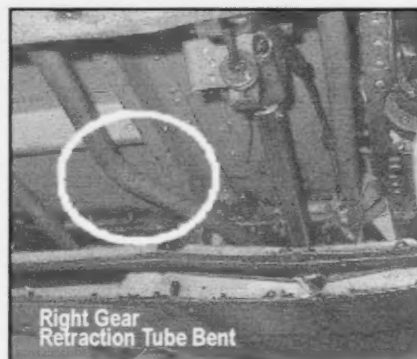
SDR #20040409001

The right main gear of a Mooney M20C aircraft, collapsed on landing roll-out. Initial investigation discovered that the main gear actuating tube inside the belly, P/N 915019000, was bent. It is unknown if this tube was bent before the incident or as result of main gear collapse.

Time Since New (TSN) : 4060 hrs

This incident is currently under investigation by the Transportation Safety Board (TSB). Due to the bent landing gear tube, the submitter was unable to determine if the gear downlock rigging was within published limits or not.

The submitter also recommends close inspection of actuating tubes for bending. These tubes are under compression load when the gear is at down and locked.

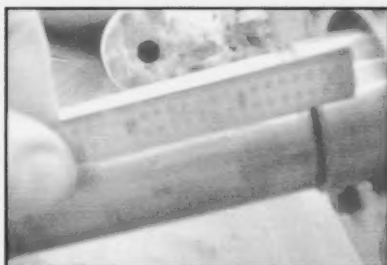
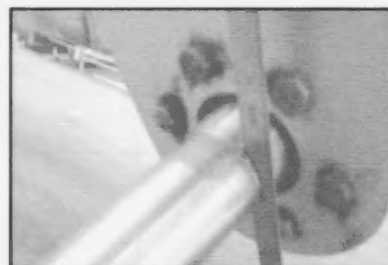
Left Main Axle Broken

The pilot was taxiing a Piper PA 31 for take-off when the left main axle, P/N 4041304, broke. After hearing vibration and noises, the pilot taxied back and discovered the left main wheel had tilted over and was rubbing on the fork assembly.

Time Since New (TSN): 16094 hrs

The submitter added that this aircraft previously landed long and fast on a short dirt runway. In departing the end of the runway, the left main gear struck a pothole and subsequently a prop strike occurred necessitating a prop and engine replacement. The runway incursion may have contributed to this premature failure of the axle.

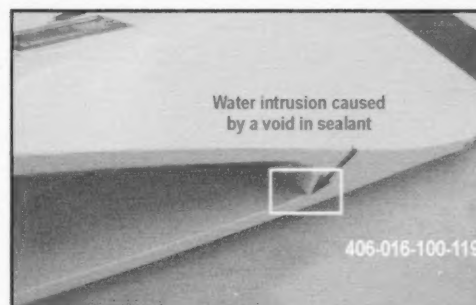
A tail rotor blade, P/N 406-016-100-119, was discovered to have absorbed water. This anomaly caused an imbalance of the tail rotor creating excessive vibrations.

Time Since New (TSN): 12.3 hrs

The manufacturer added that the water ingress might have been caused by a void in the sealant.
